**A.A. County Potential IMPs - Site 33**

**UPPER PATUXENT RIVER WATERSHED RESTORATION ACTION STRATEGY (WRAS)  
FORM 1 -- Catchment Information**

**UPPER PATUXENT RIVER WATERSHED RESTORATION ACTION STRATEGY (WRAS)  
FORM 2 -- Site Information**

Site Name: \_\_\_\_\_ Address: 2135 and 2137 Espey Court

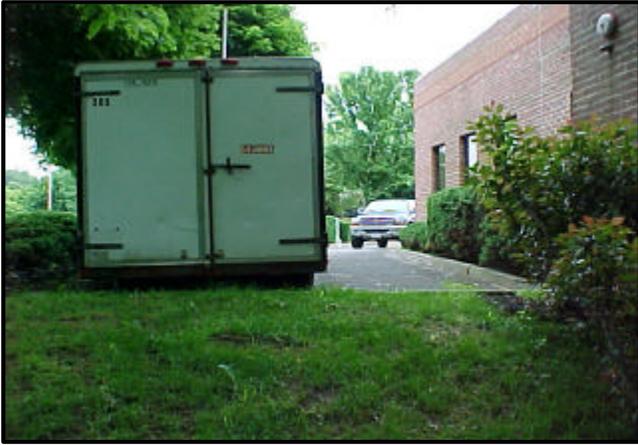
96

No. <u>96</u>	Description: <u>looking northeast along north side of 2137 Espey Court</u>
No. <u>97</u>	Description: <u>looking south between 2135 and 2137 Espey Court</u>
No. <u>98</u>	Description: <u>looking north between 2135 and 2137 Espey Court</u>
No. <u>99</u>	Description: <u>looking east along south side of property</u>
No. <u>100</u>	Description: <u>looking north along east side of property</u>
No. <u>101</u>	Description: <u>looking west along south side of property</u>
No. <u>102</u>	Description: <u>looking west along north side of property</u>
No. <u>103</u>	Description: <u>looking south along east side of property</u>
No. _____	Description: _____
No. _____	Description: _____

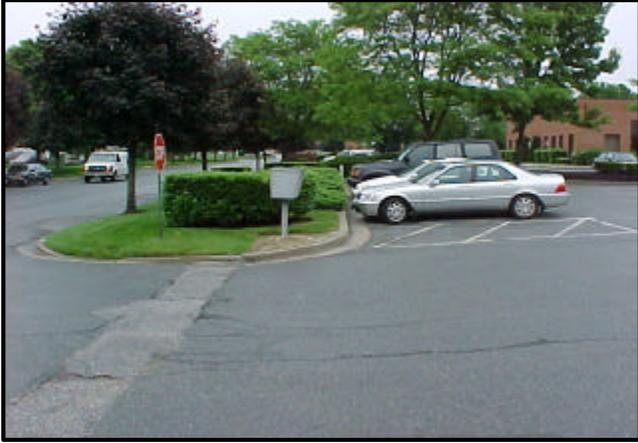
108

No. <u>108</u>	Description: <u>looking east</u>
No. <u>109</u>	Description: <u>looking south</u>
No. _____	Description: _____

**Comments** Maximum of 2 parking spots can be affected. Must relocate mailbox. Install "speed bump" to direct flow.  
IMP size = 366 sq ft  
 \_\_\_\_\_  
 \_\_\_\_\_  
 \_\_\_\_\_  
 \_\_\_\_\_  
 \_\_\_\_\_

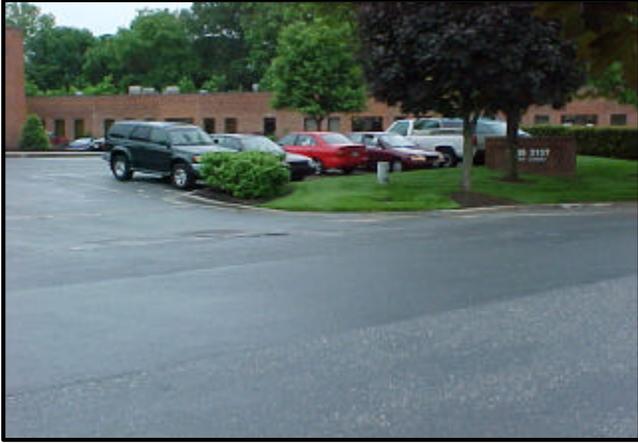
110

No. <u>110</u>	Description: <u>looking southwest</u>
No. _____	Description: _____

**Comments** Use maximum of 2 parking spots. Construct "speed bump" to direct flow.  
IMP size = 645 sq ft  
 \_\_\_\_\_  
 \_\_\_\_\_  
 \_\_\_\_\_  
 \_\_\_\_\_  
 \_\_\_\_\_  
 \_\_\_\_\_

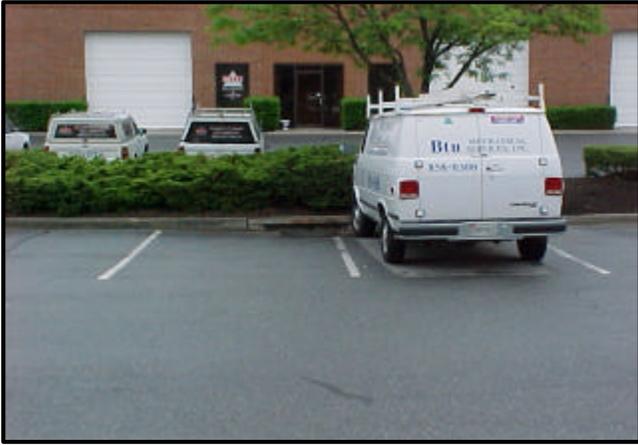
112

No. <u>112</u>	Description: <u>looking east</u>
No. <u>113</u>	Description: <u>looking south</u>
No. _____	Description: _____

**Comments** Bioretention area provides 65% treatment as sized.  
IMP size = 645 sq ft  
 \_\_\_\_\_  
 \_\_\_\_\_  
 \_\_\_\_\_  
 \_\_\_\_\_  
 \_\_\_\_\_  
 \_\_\_\_\_

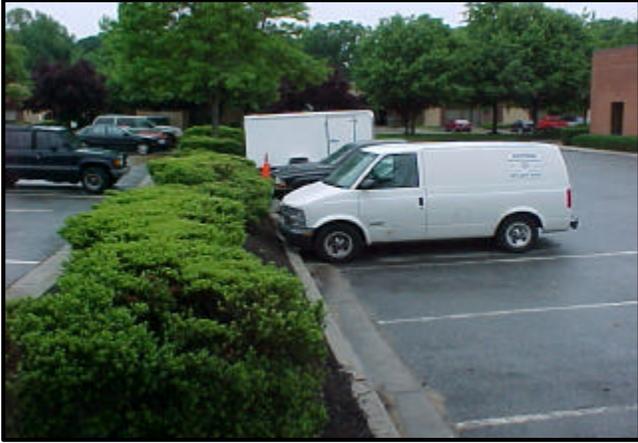
114

No. <u>114</u>	Description: <u>looking south</u>
No. <u>115</u>	Description: <u>looking east</u>
No. _____	Description: _____

**Comments** Bioretention provides 52% treatment of drainage area as sized.  
IMP size = 6542 sq ft  
 \_\_\_\_\_  
 \_\_\_\_\_  
 \_\_\_\_\_  
 \_\_\_\_\_  
 \_\_\_\_\_  
 \_\_\_\_\_

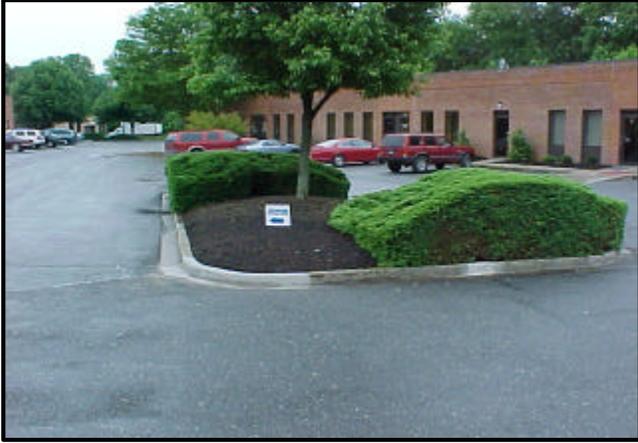
116

No. <u>116</u>	Description: <u>looking south</u>
No. <u>117</u>	Description: <u>looking west</u>
No. _____	Description: _____

**Comments** Bioretention provides 39% treatment of drainage area as sized.  
IMP size = 507 sq ft  
 \_\_\_\_\_  
 \_\_\_\_\_  
 \_\_\_\_\_  
 \_\_\_\_\_  
 \_\_\_\_\_  
 \_\_\_\_\_
